GENERAL TECHNICAL POLICIES AND INFORMATION BULLETINS

7

11-13-50

DRIVE
INDICATOR
BREAKAGE

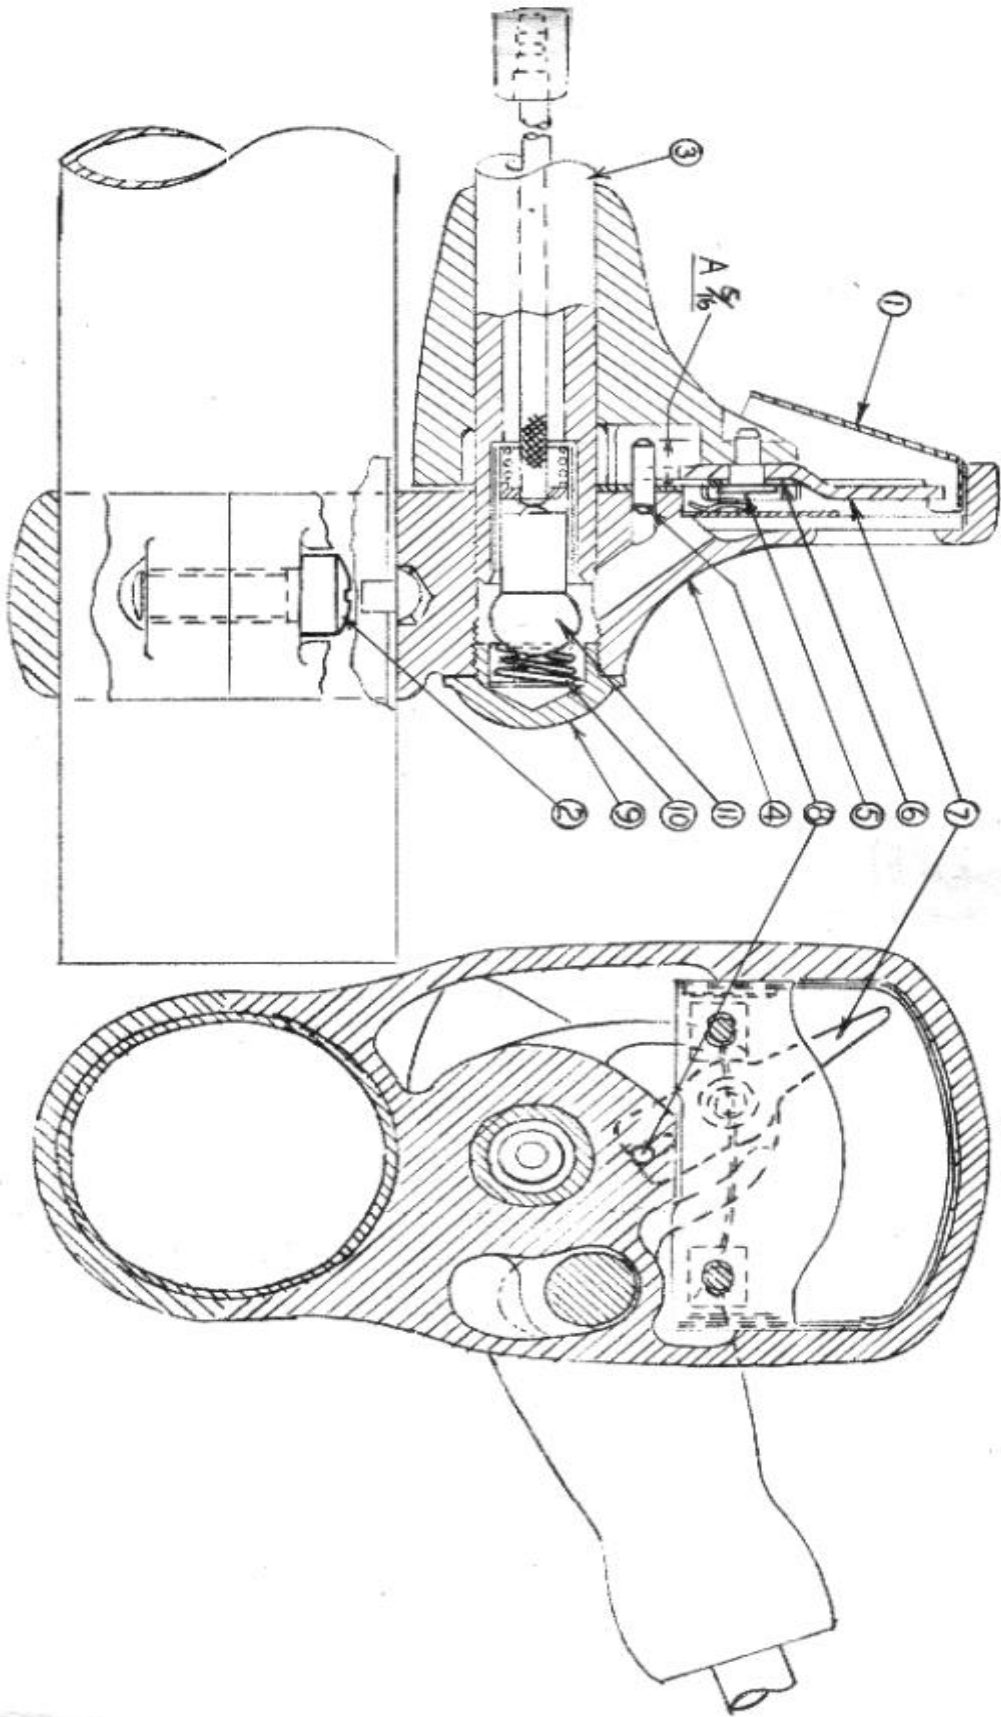
Some reports have been received from the field regarding breakage of the plastic indicator mounted on the transmission control tube bracket at the top of the steering column on cars equipped with Hydra-Matic Drive. This indicator is actuated by the selector lever and shows which range the transmission control is in.

Indicator breakage in most cases is caused by the drive indicator dial pin #8, (part #171571) being too short, resulting in the indicator being assembled with the pin outside the fork instead of in it. Replacement of the indicator and correction of the cause of breakage is accomplished as outlined below and on the attached sketch.

- (1) Remove snap type cover (1) from transmission control tube bracket by light pry with screwdriver under cover.
- (2) Remove two screws (2) holding transmission control tube bracket and cap to steering column.

- (3) Lift up on shift lever to separate transmission control tube bracket from steering column and allow bracket to clear rivet head in steering column tube. In this position, transmission control tube bracket may now be separated from transmission control tube (3) and expose the drive indicator.

- (4) Using a small 3/32" punch knock-out drive indicator pin (5) which retains drive indicator (7) and drive indicator spring washer (6) to shift control tube.

- (5) Replace broken drive indicator and reinstall spring washer and drive indicator pin in shift control tube assembly.
- (6) Increase dimension of pin #8 in transmission control tube bracket to 5/16" as shown in illustration by pulling pin out of bracket with pliers to required dimension as measured from control tube bracket casting to end of pin. Remove all burrs from pin resulting from the above procedure.

- (7) Lift up on shift control tube and reinstall control tube bracket to shift control tube. Secure alignment of pin #8 and yoke of drive indicator (7) by moving drive indicator with fingers during engagement of control tube bracket to control tube.

- (8) Reinstall transmission control tube bracket cap to transmission control tube bracket and tighten cap screws securely.
