# 1956 AMC-Hudson

Groups 1.000 thru 13.000

# AMERICAN MOTORS CORPORATION

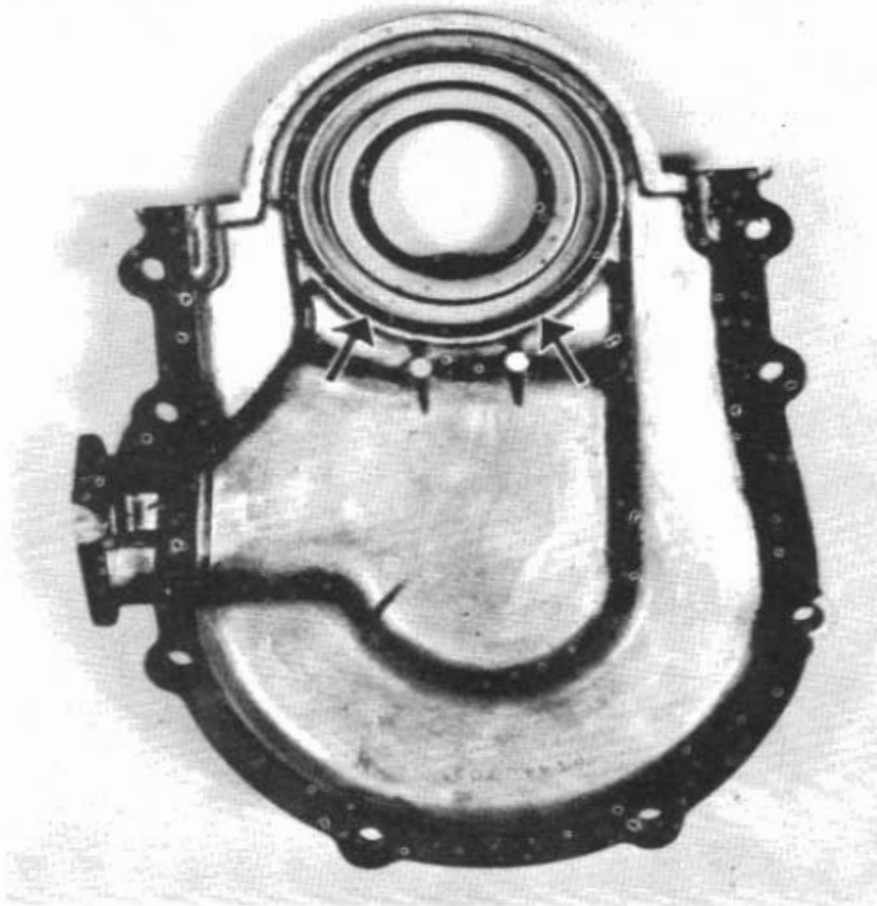
An oil leak at the front timing chain cover oil seal may result from a lack of an interference fit of the seal in the cover. This would permit the seal to turn with the crankshaft,

FIGURE 1  
Approximate Location of  $11/64$ " Diameter Holes  
Drilled in Timing Chain Cover

To effect a correction for this condition, the following procedure is recommended:

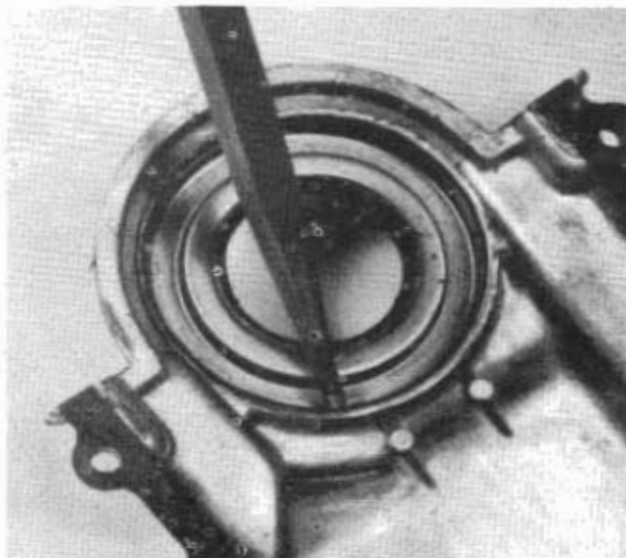
FIGURE 2  
"Upset" Seal Material  
Into Drilled Holes in Cover

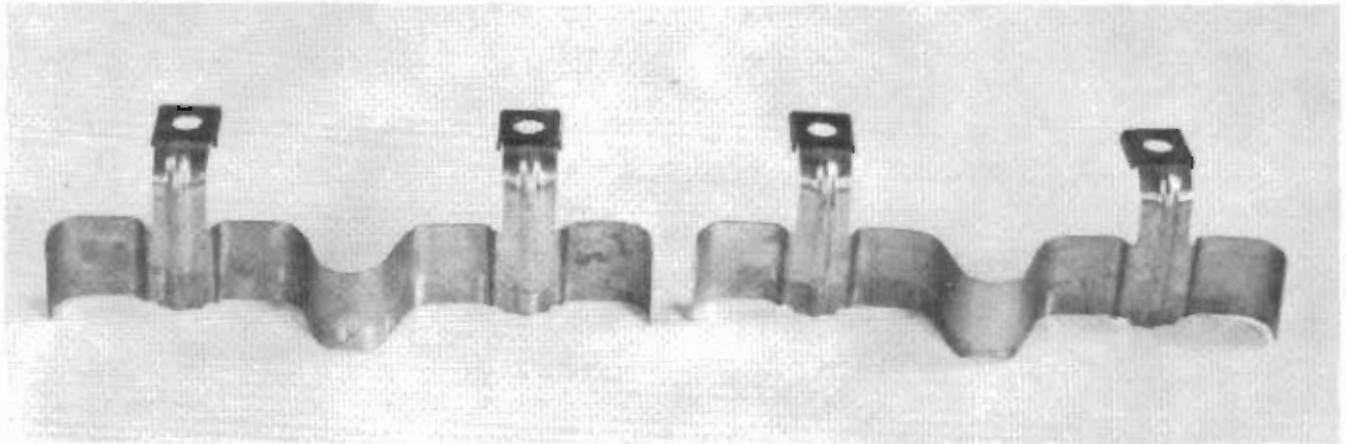
FIGURE 1

Valve Spring Baffles, Part Number 6489127,  
Contained in Kit, Part Number 6484396

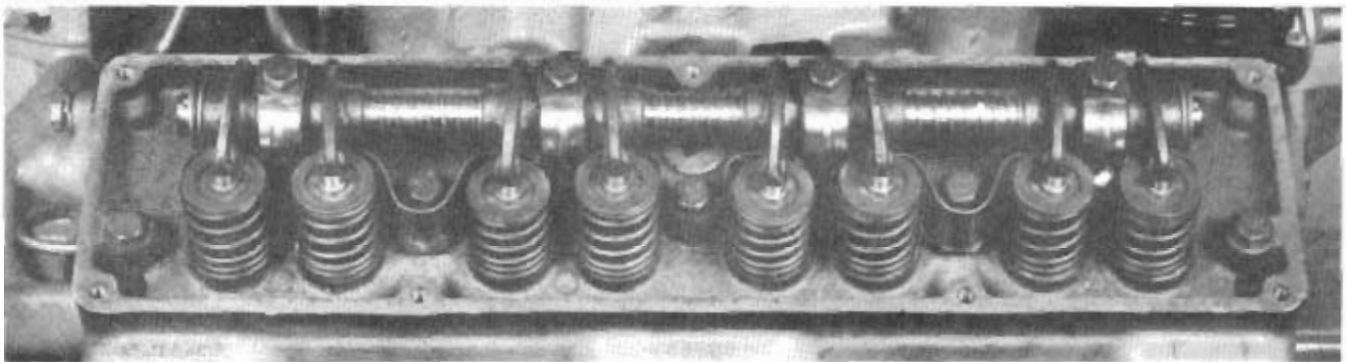
FIGURE 2

Service Baffles Installed

Place the baffles in position on the rocker arm assembly as shown in Figure 2. Install the assembly on the cylinder head. Replace the original rocker arm shaft bolt lockwashers with the square type lockwashers.

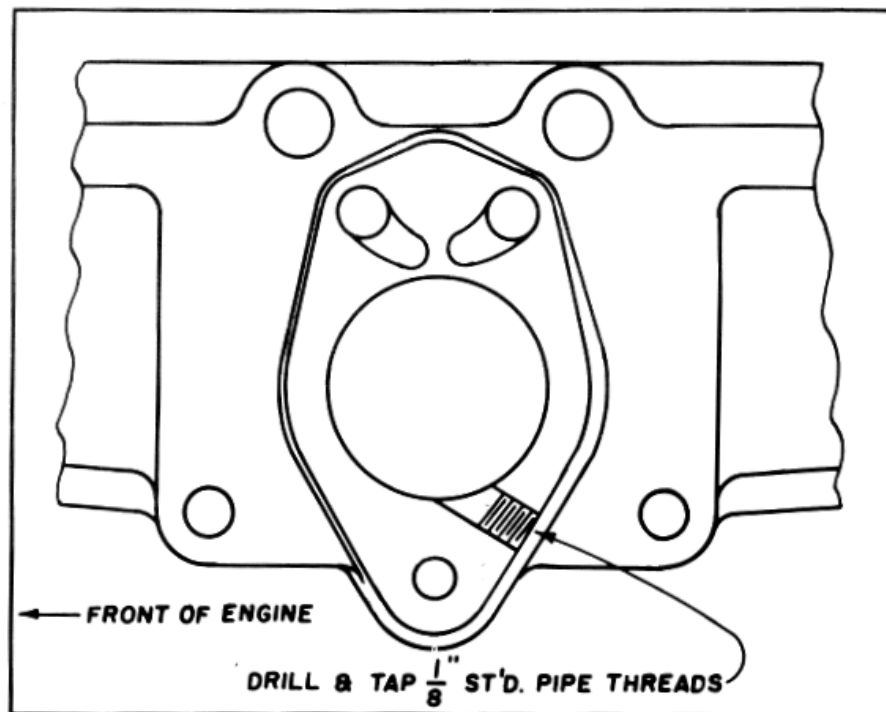
FIGURE 1

Rough engine idle caused by windshield wiper operation may be improved by relocating the vacuum booster pump outlet connection to the left rear side of the intake manifold cover carburetor mounting pad.

Mark and drill a  $21/64$ " hole in the left rear side of the carburetor mounting pad as shown in the illustration.

Tap the hole with a  $1/8$ " standard tapered pipe thread.

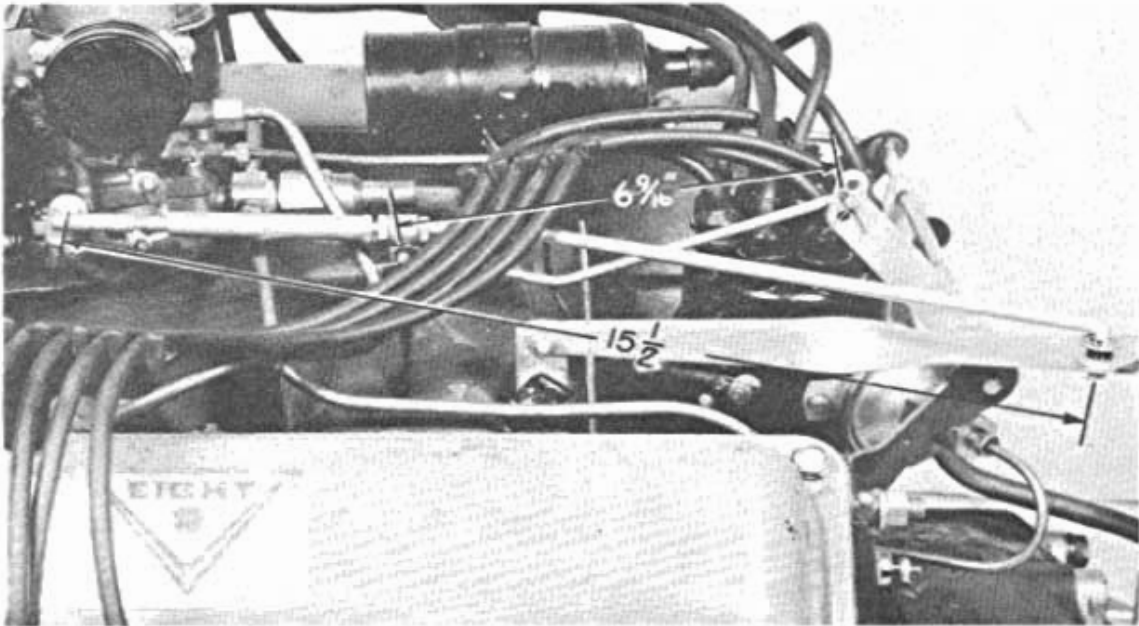
FIGURE 1  
CARBURETOR THROTTLE ROD AND  
ADJUSTER ROD MEASUREMENT

After measurement, have been corrected, warm up engine and set carburetor idle at 400 RPM. Stop the engine and loosen the two lock nuts at the front and rear end of the adjuster on the rod. **PLACE THE REAR END OF THE ROD IN THE CENTER HOLE OF THE CROSS SHAFT LEVER.** Finger tighten the two lock nuts so that the adjuster rod fits freely in the lever.

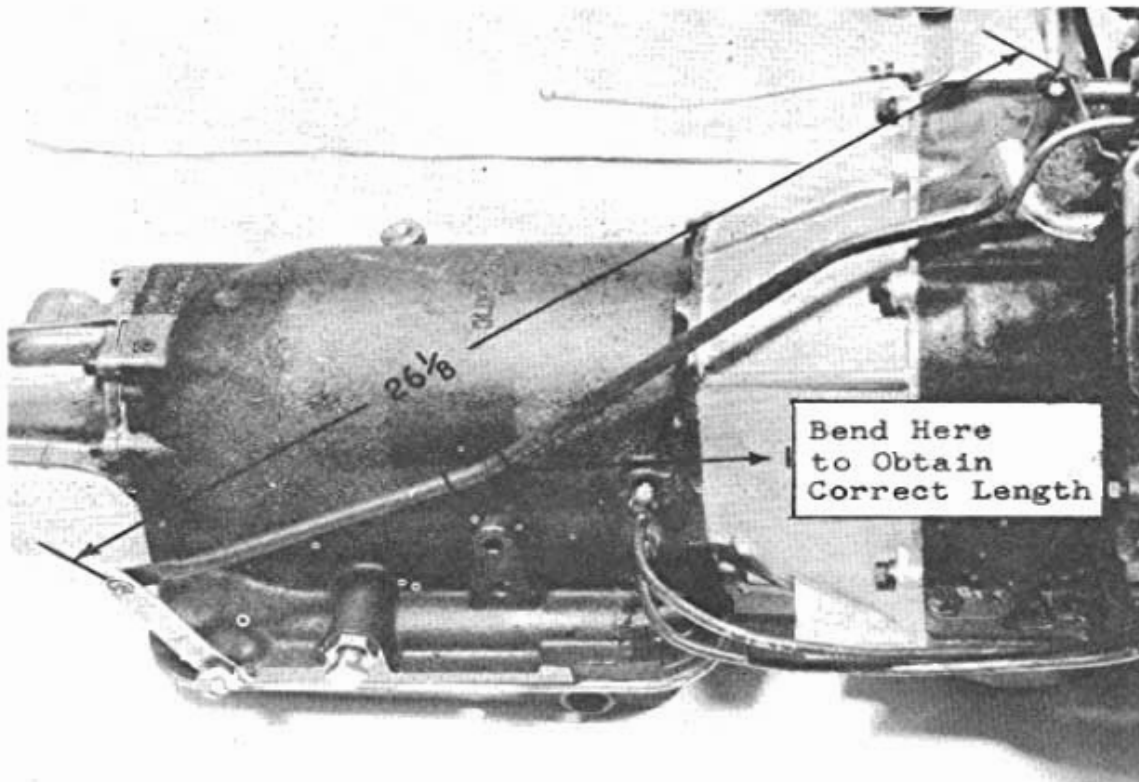
FIGURE 2  
T.V. ROD MEASUREMENT

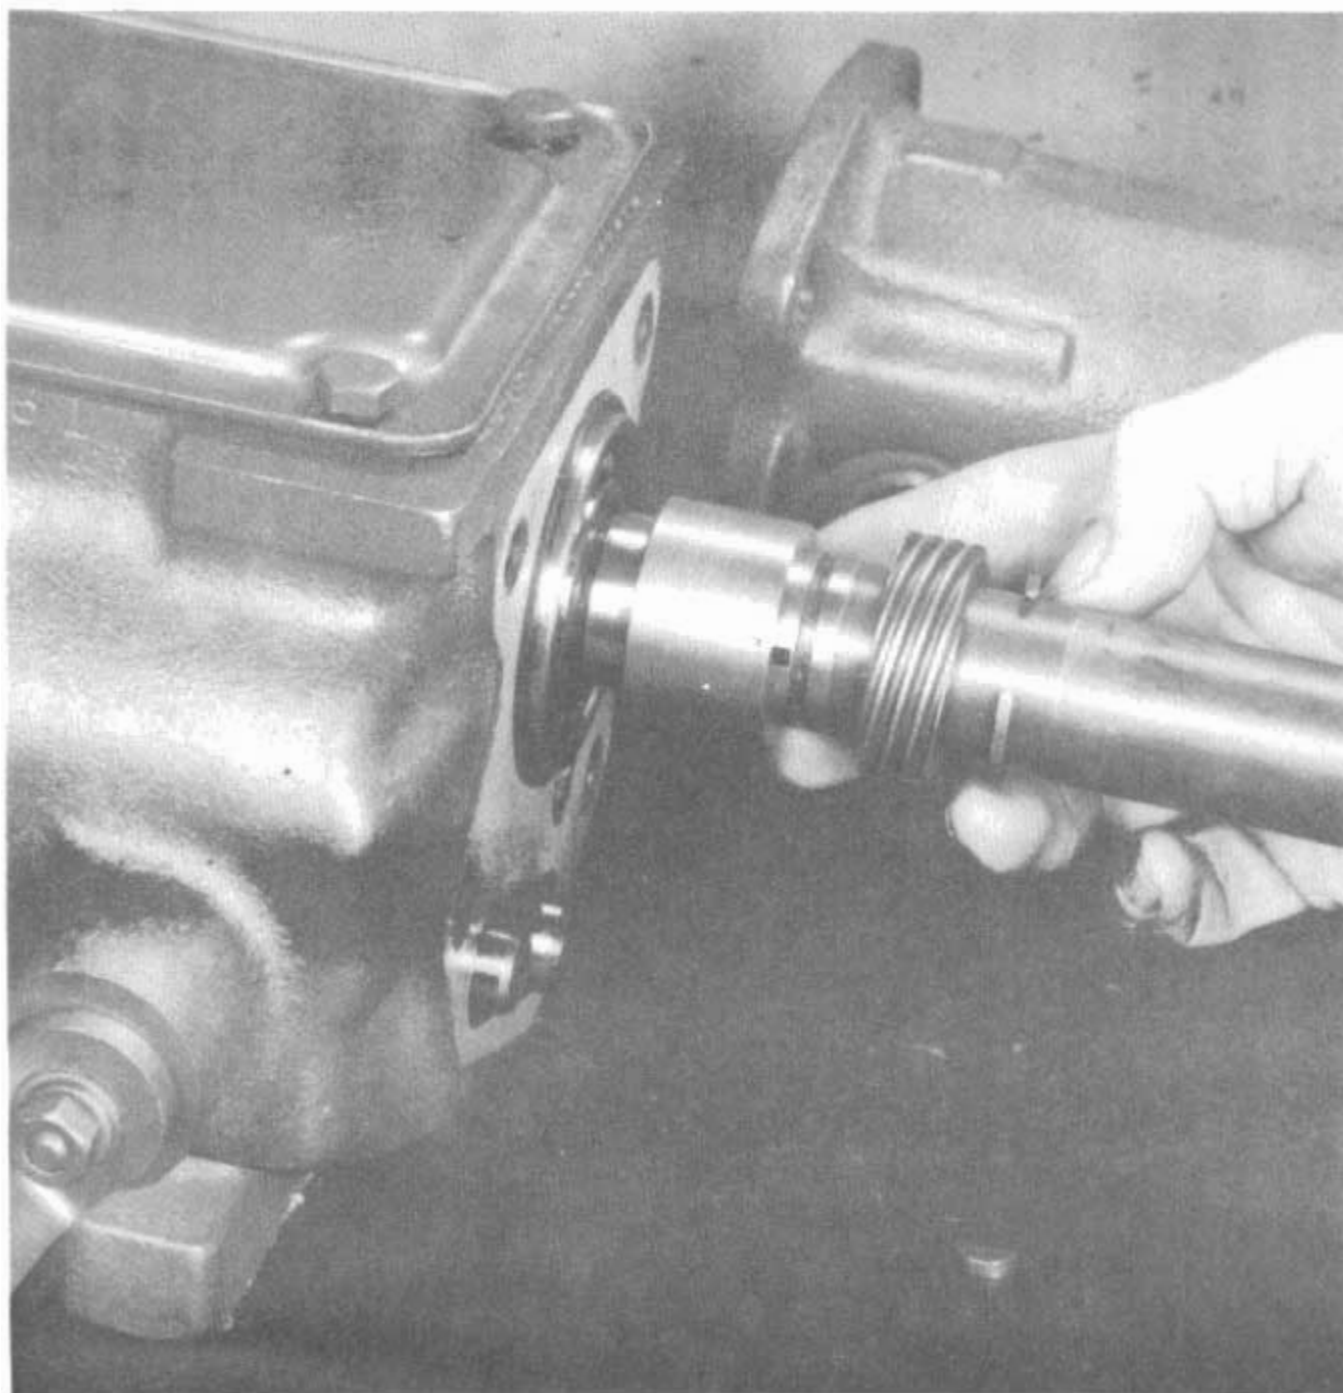
REAR BEARING SNAP RING FAILURE,  
STANDARD TRANSMISSION - 1955-56  
"40" SERIES

SLEEVE, PART NUMBER 3149883  
1955-56 "40" SERIES STANDARD TRANSMISSION

Where failure of this nature is encountered, install sleeve, Part Number 3149883, (supplied for service only) by removing the rear extension housing, three snap rings, and speedometer drive gear.

Install the sleeve against the bearing and replace the Woodruff key and speedometer drive gear. Select fit one snap ring in the groove at the rear of the speedometer drive gear to provide zero end clearance.

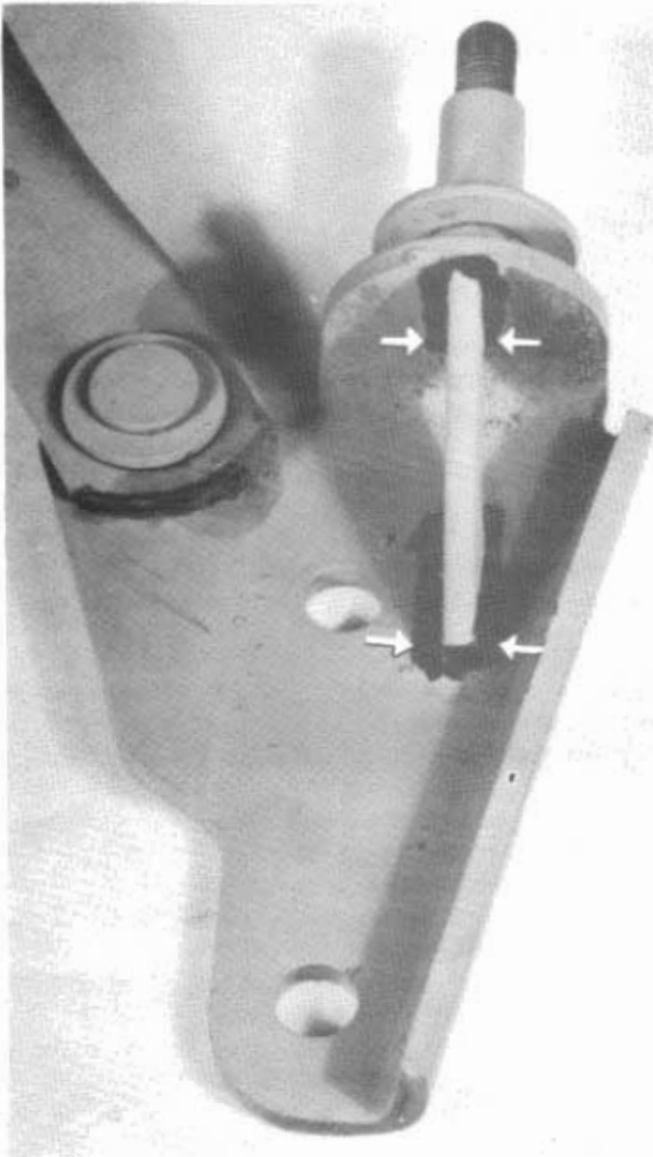
Effective at car serial number D-277527, a brace, Part Number 3148777, was added to the rear axle truss rod and shock absorber bracket to prevent bending of the bracket and resultant shock absorber damage.

FIGURE 1  
Shock Absorber Lower Mounting  
Bracket Brace

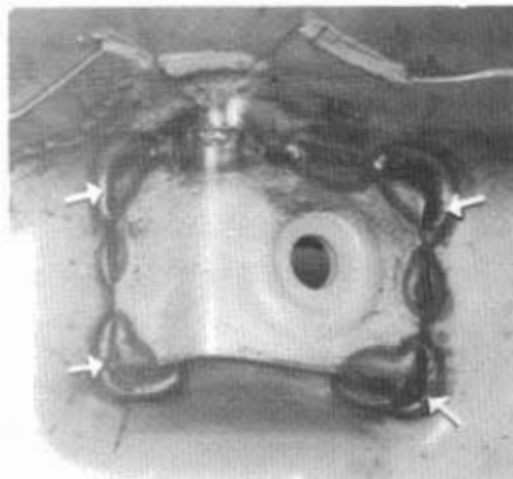
FIGURE 2  
Shock Absorber  
Upper Mounting Reinforcement
