# 1956 AMC-Hudson

Groups 1.000 thru 13.000

# AMERICAN MOTORS CORPORATION

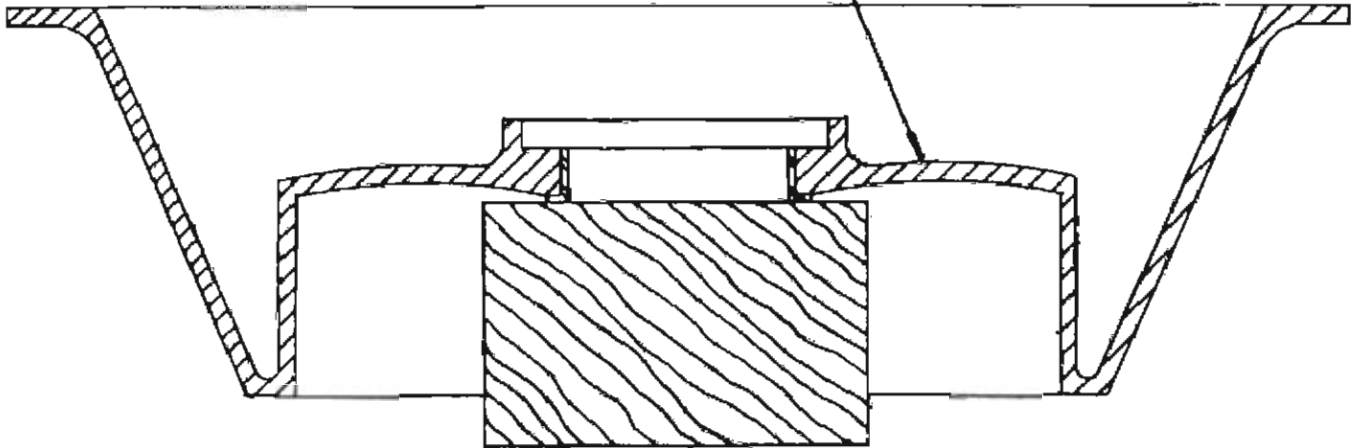
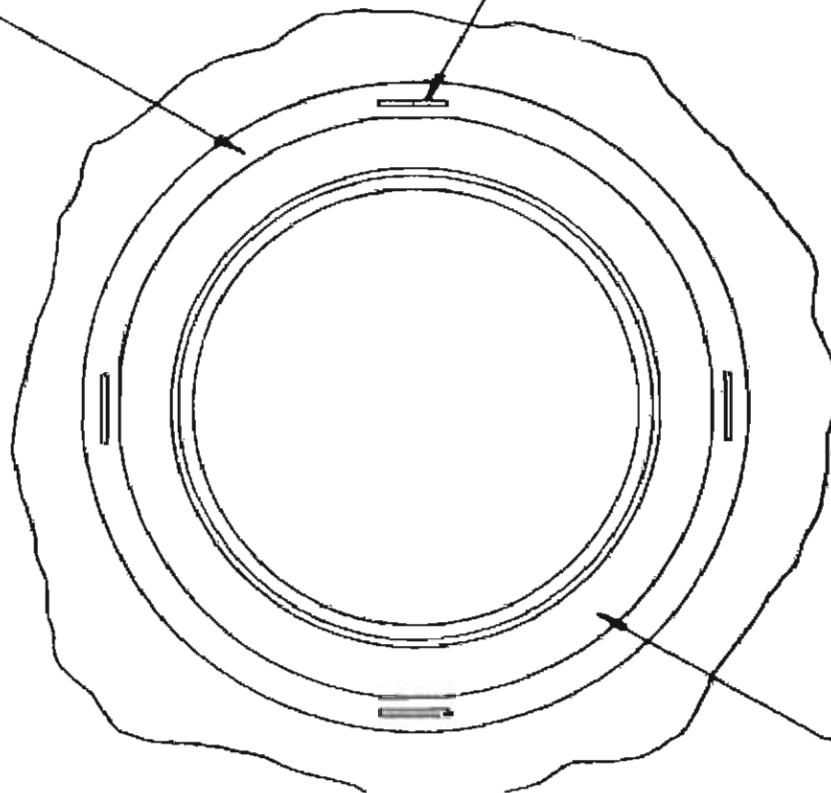
### FRONT SEAL INSTALLATION

The above recommendations are made in order to insure that the housing is not damaged when the seal is installed.

The recommended procedure is as follows:

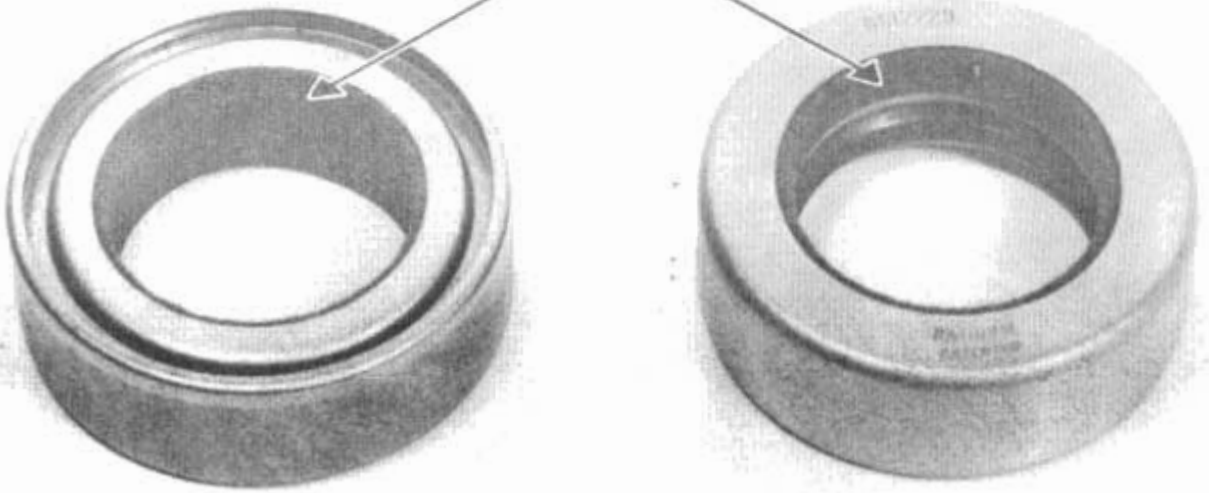
PART NUMBER 3114778,  
REAR BEARING RETAINER OIL SEALS

Felt Lower Rear  
of Transmission
